## BEFORE / AFTER DOCUMENTATION

Job completion evidence · paired pre-work and post-work capture · single-family residence

| <b>Property</b> | Single-family residence · address withheld | <b>Report ID</b> | MWA-SMP-0007 |
| <b>Scope of work</b> | Full roof replacement — architectural shingle | <b>Work order</b> | Withheld on this sample |

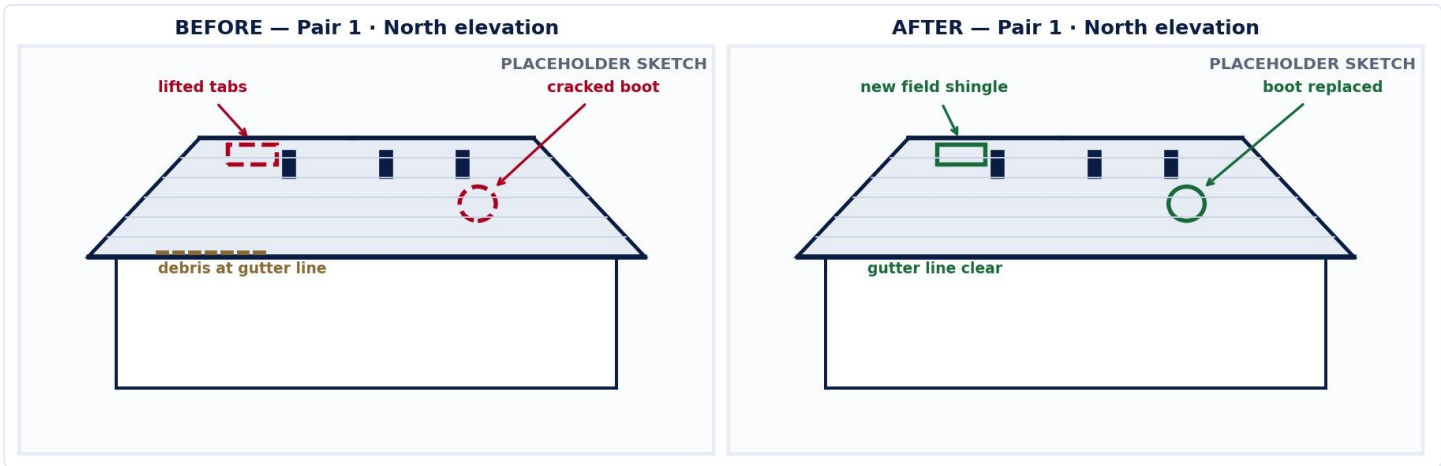
| LOCATION | OBSERVATION | SEVERITY |
|---|---|---|
| North elevation | Pre-work and post-work frames captured from matched altitude and heading; pairs align for direct comparison (Fig. 1) | LOW |

Fig. 1 — Reference sketch — how each elevation pair is presented, before beside after, at matched altitude and heading.
