# HOA COMMON-AREA SURVEY

Association common areas · amenity buildings, turf, stormwater and access · capture date withheld

| Community | Address withheld | Report ID | MWA-SMP-0005 |

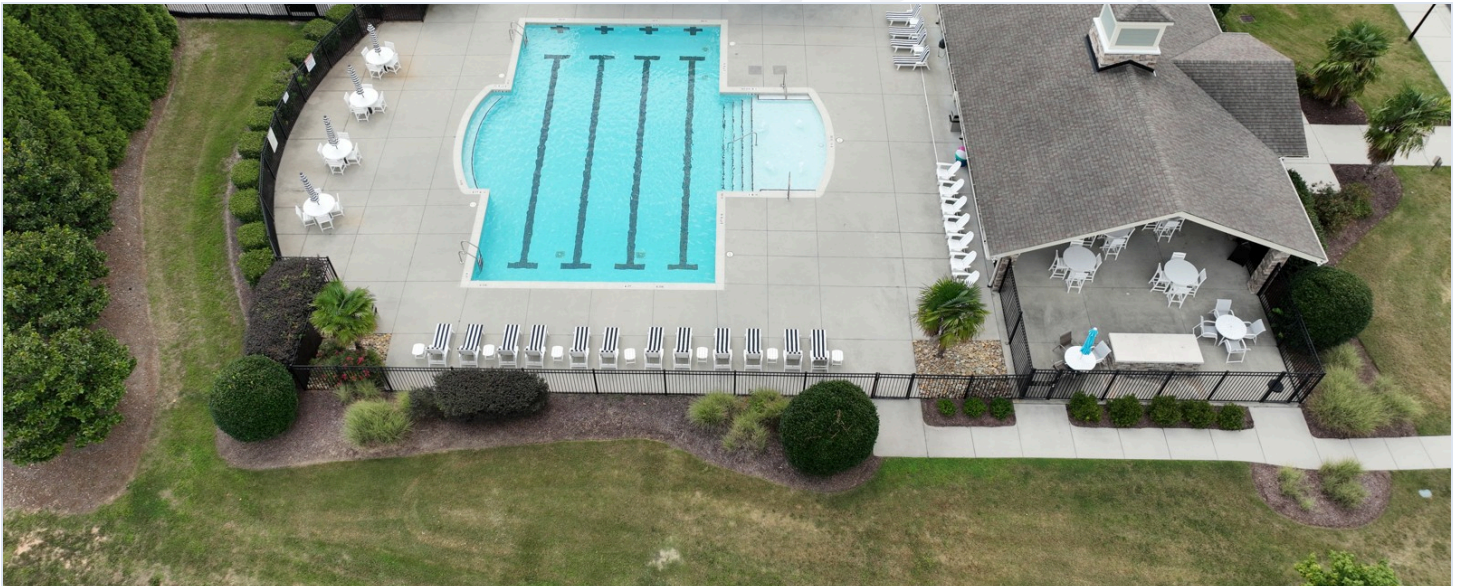
| LOCATION | OBSERVATION | SEVERITY |
|---|---|---|
| Amenity center and pool deck | Roof surface, shade structures, deck, perimeter fencing and furniture recorded as found; no displaced material or standing water observed on the deck (Figs. 1–2) | <b>LOW</b> |

Fig. 1 — Amenity center and pool deck on the date of flight. Roof, shade structures, deck, perimeter fencing and furniture in a single orienting frame.

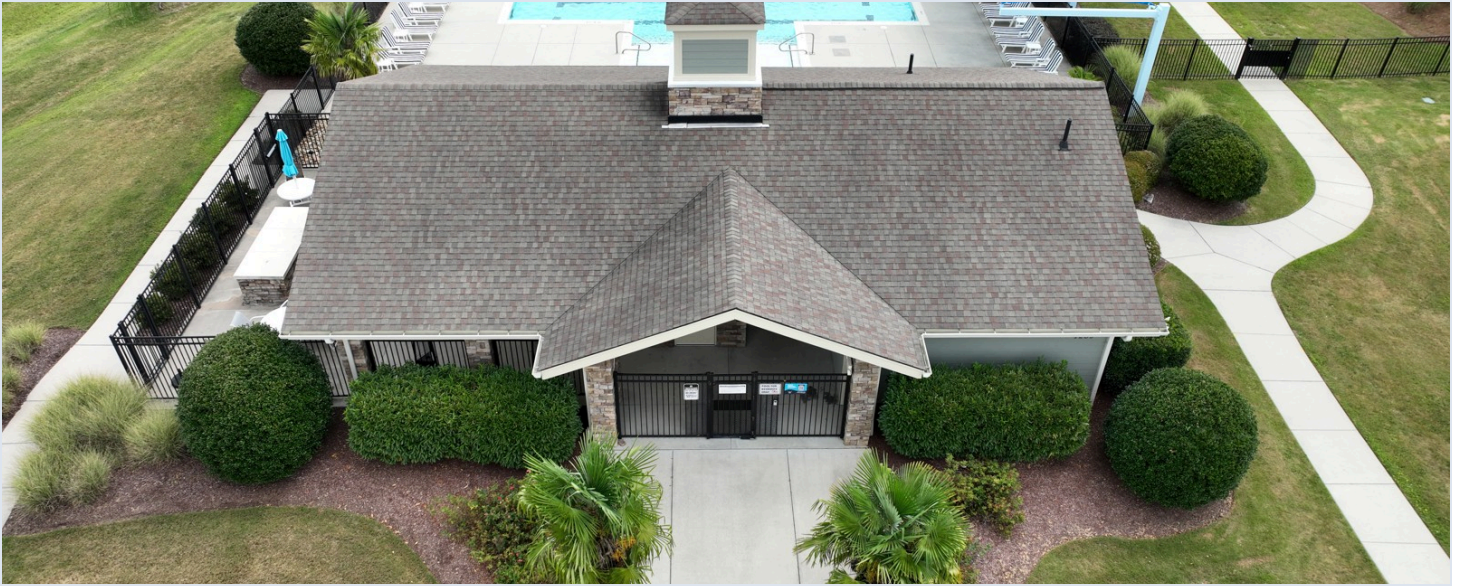
*Fig. 2 — Pool enclosure and clubhouse approach; deck surface, walkway and landscape beds.*

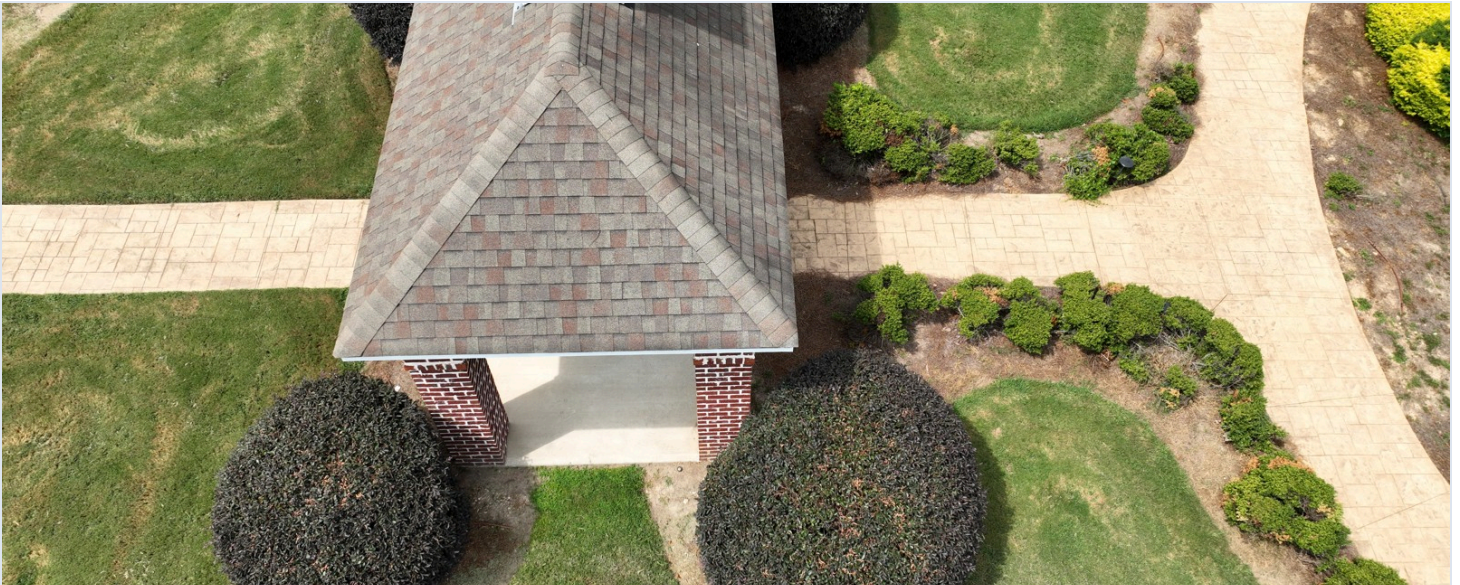
| LOCATION | OBSERVATION | SEVERITY |
|---|---|---|
| Pavilion | Roof, columns and surrounding walkway and beds recorded in a single overhead frame for the reserve file (Fig. 3) | <b>LOW</b> |

*Fig. 3 — Picnic pavilion, photographed from directly overhead; roof surface, walkway and surrounding beds.*

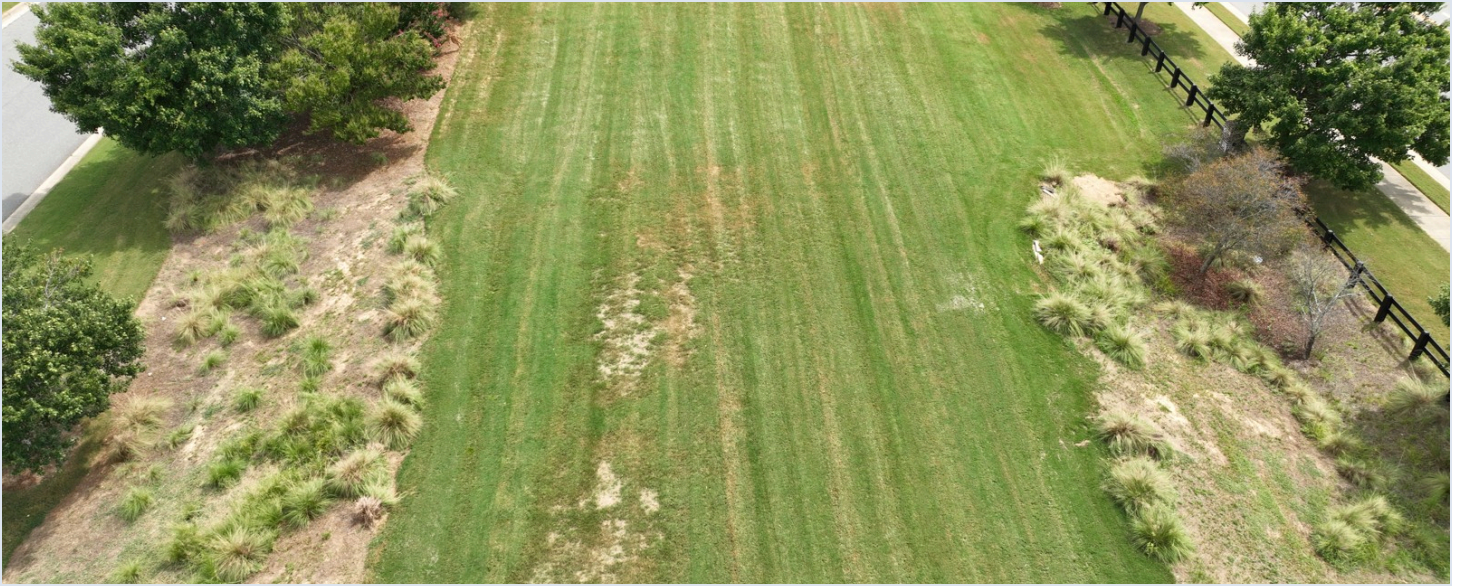
| LOCATION | OBSERVATION | SEVERITY |
|---|---|---|
| Common turf | Bare and thinning patches across the central maintained area, with mower striping visible and established edge planting on both banks (Figs. 4–5) | <b>MEDIUM</b> |

*Fig. 4 — Common turf area. Bare and thinning patches across the central maintained section, with established edge planting on both banks.*

Retain this capture as the dated baseline for the association's common areas. Repeat the same flight positions at the next survey so two dates can be compared without argument about the angle — that comparison is what turns a photograph into evidence for a reserve study or a capital request. The forebay sediment and the turf areas are the two items most likely to change measurably between visits and are the reason to hold a dated record now.

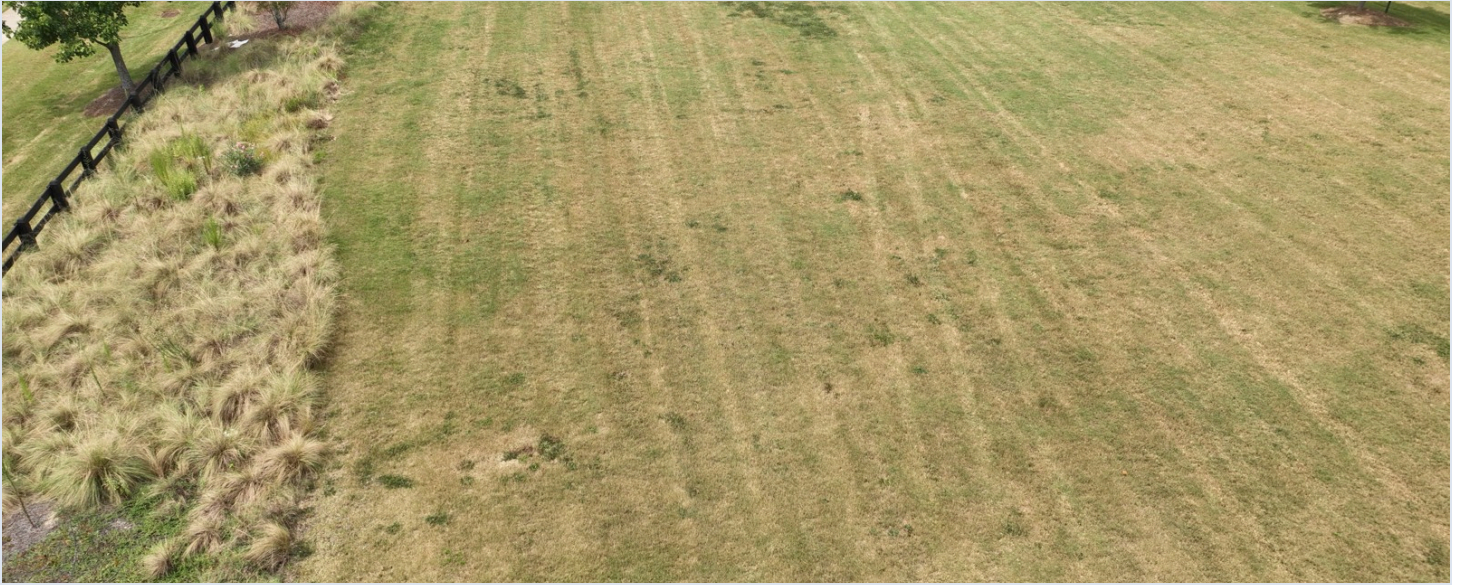
*Fig. 5 — Second common turf area; mown surface condition and tree line at the boundary.*

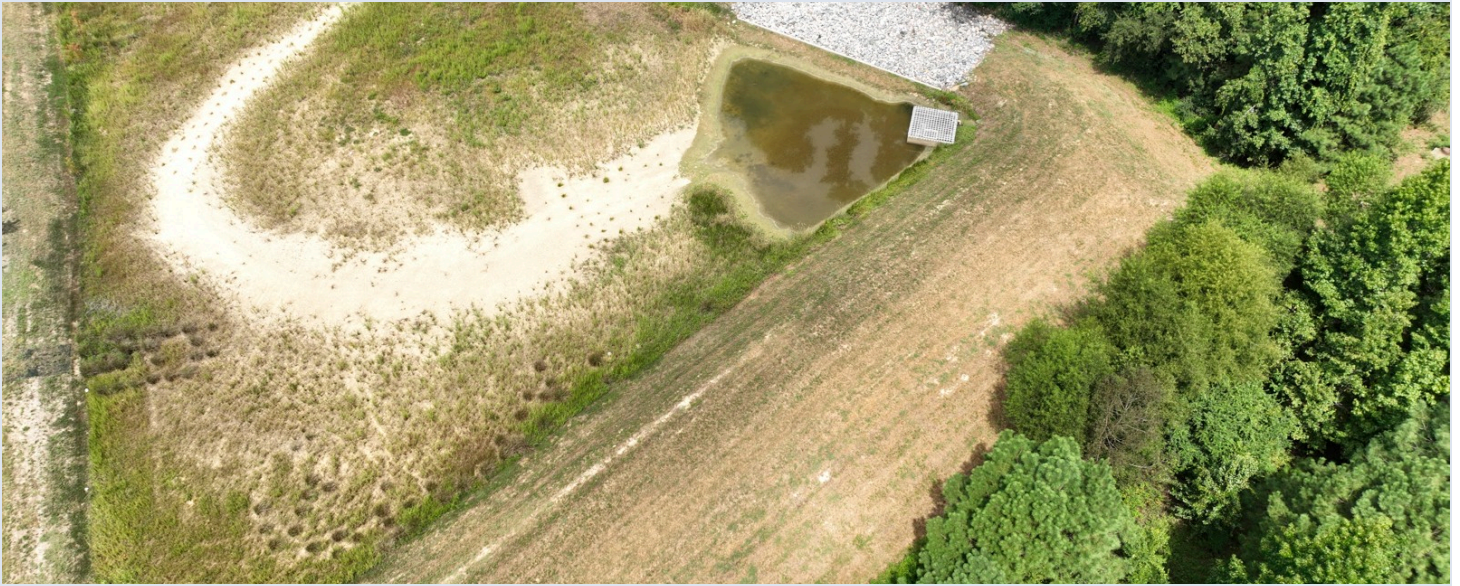
| LOCATION | OBSERVATION | SEVERITY |
|---|---|---|
| Stormwater control measure | Sediment accumulation visible across the forebay, with the deposit surface dry and exposed on the date of flight. Outlet structure and grate clear and unobstructed; rip-rap emergency spillway in place (Figs. 6–7) | <b>MEDIUM</b> |

*Fig. 6 — Stormwater control measure. Forebay with sediment accumulation, permanent pool, outlet structure and rip-rap emergency spillway.*

Where compliance, conformance or quantity is in question, refer to the association's engineer or a qualified stormwater professional; this report records condition only.

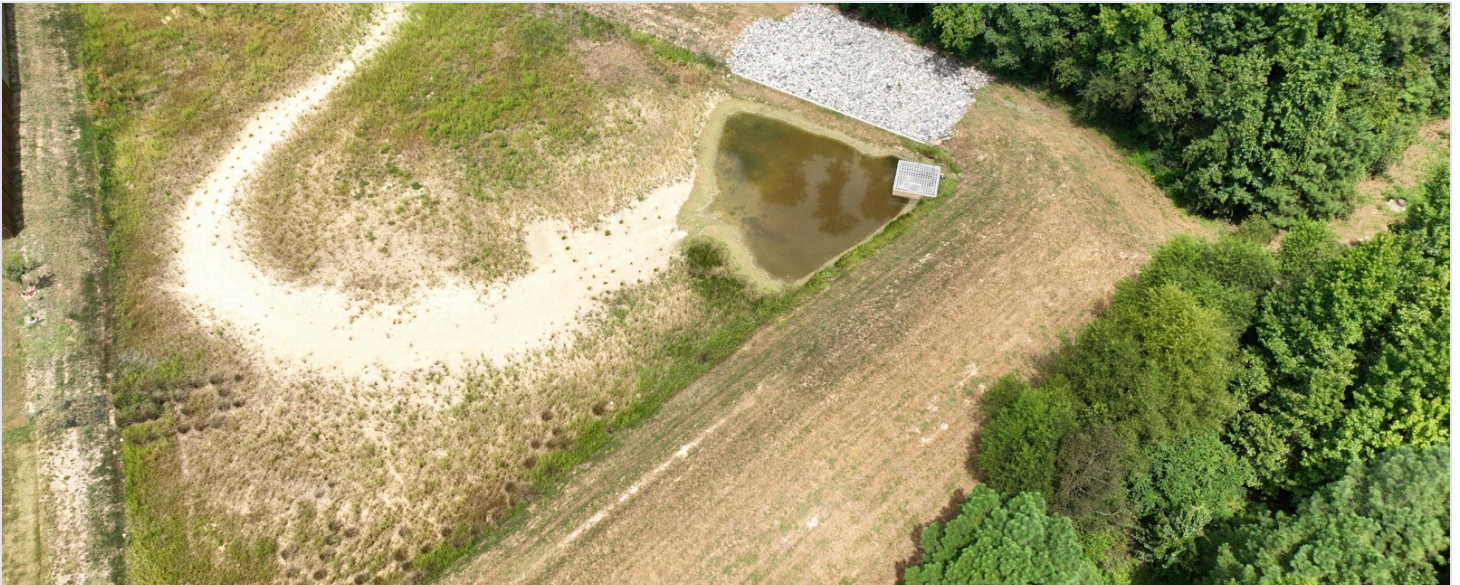
*Fig. 7 — Outlet structure and channel at closer altitude; grate clear, surrounding vegetation established.*

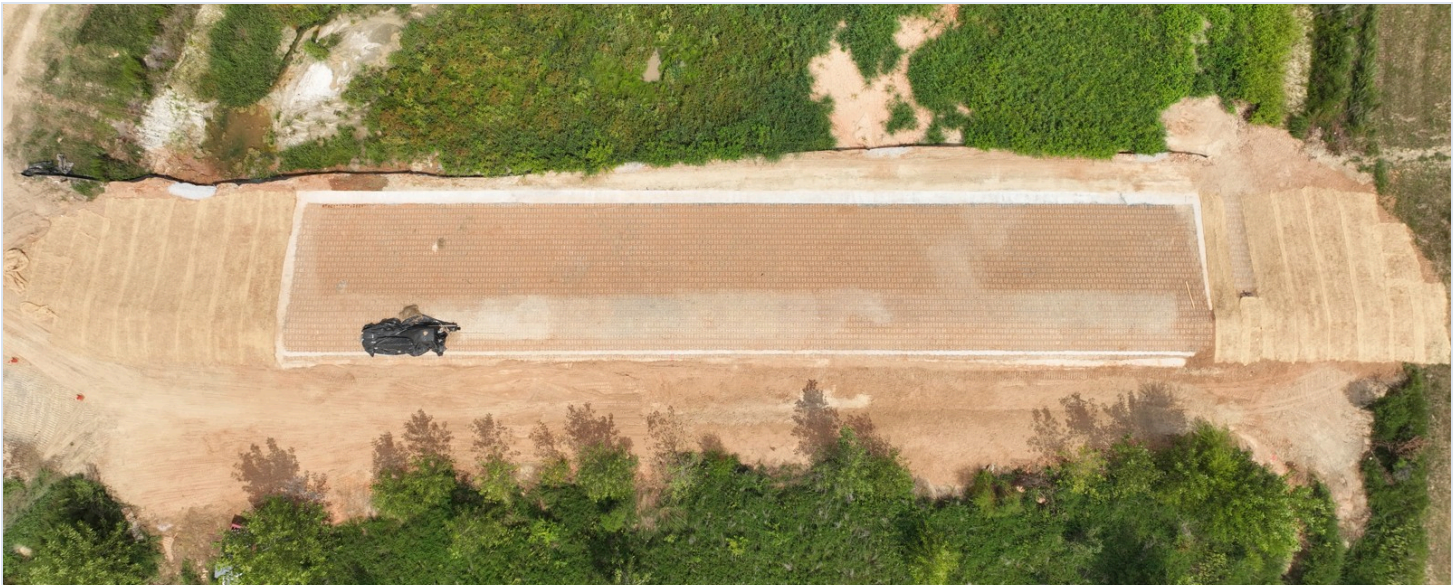
| LOCATION | OBSERVATION | SEVERITY |
|---|---|---|
| Maintained path | Graded section with an unsurfaced running surface and defined shoulders (Fig. 8) | <b>LOW</b> |

Fig. 8 — Maintained path; graded running surface and defined shoulders.

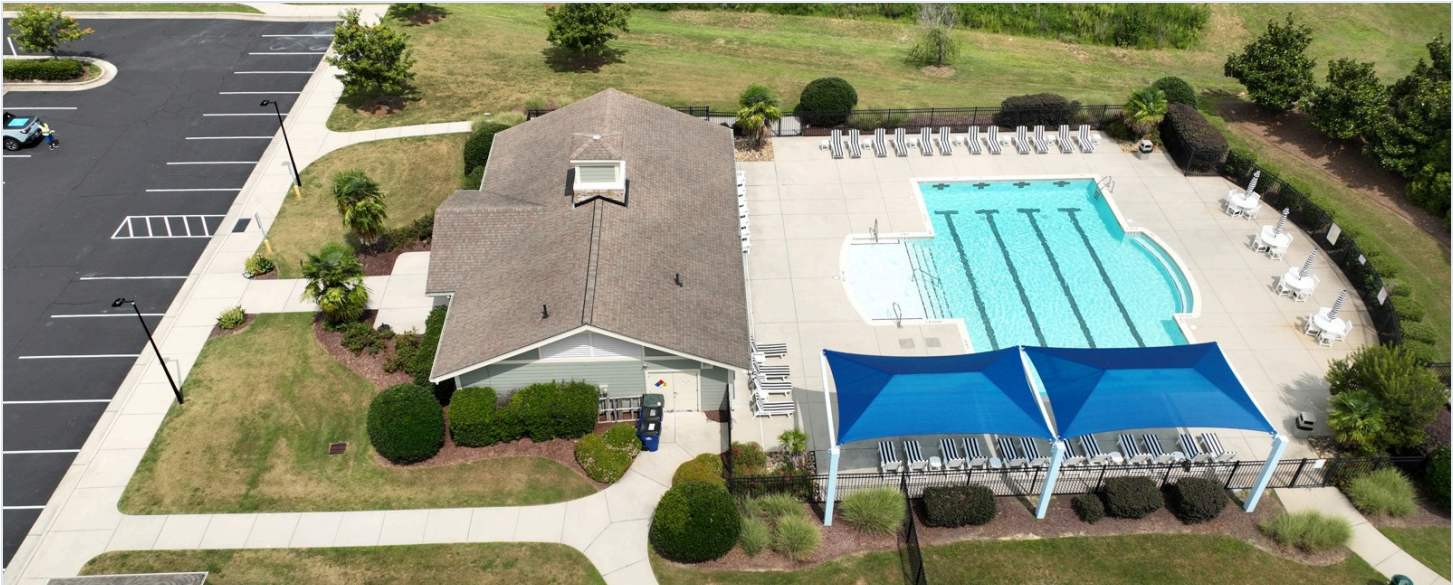
| LOCATION | OBSERVATION | SEVERITY |
|---|---|---|
| Access drive and parking | Surface, striping and curb line recorded; no ponding visible on the date of flight (Fig. 9) | <b>LOW</b> |

Fig. 9 — Access drive and parking serving the amenity center; surface, striping and curb line.
