# AERIAL ROOF INSPECTION REPORT

Residential roof surfaces and perimeter · capture date withheld

| Property | Wake County, NC · street address withheld | Report ID | MWA-SMP-0002 |
| Scope | Roof surfaces, perimeter and gutter line | Turnaround | Within 24 hours |

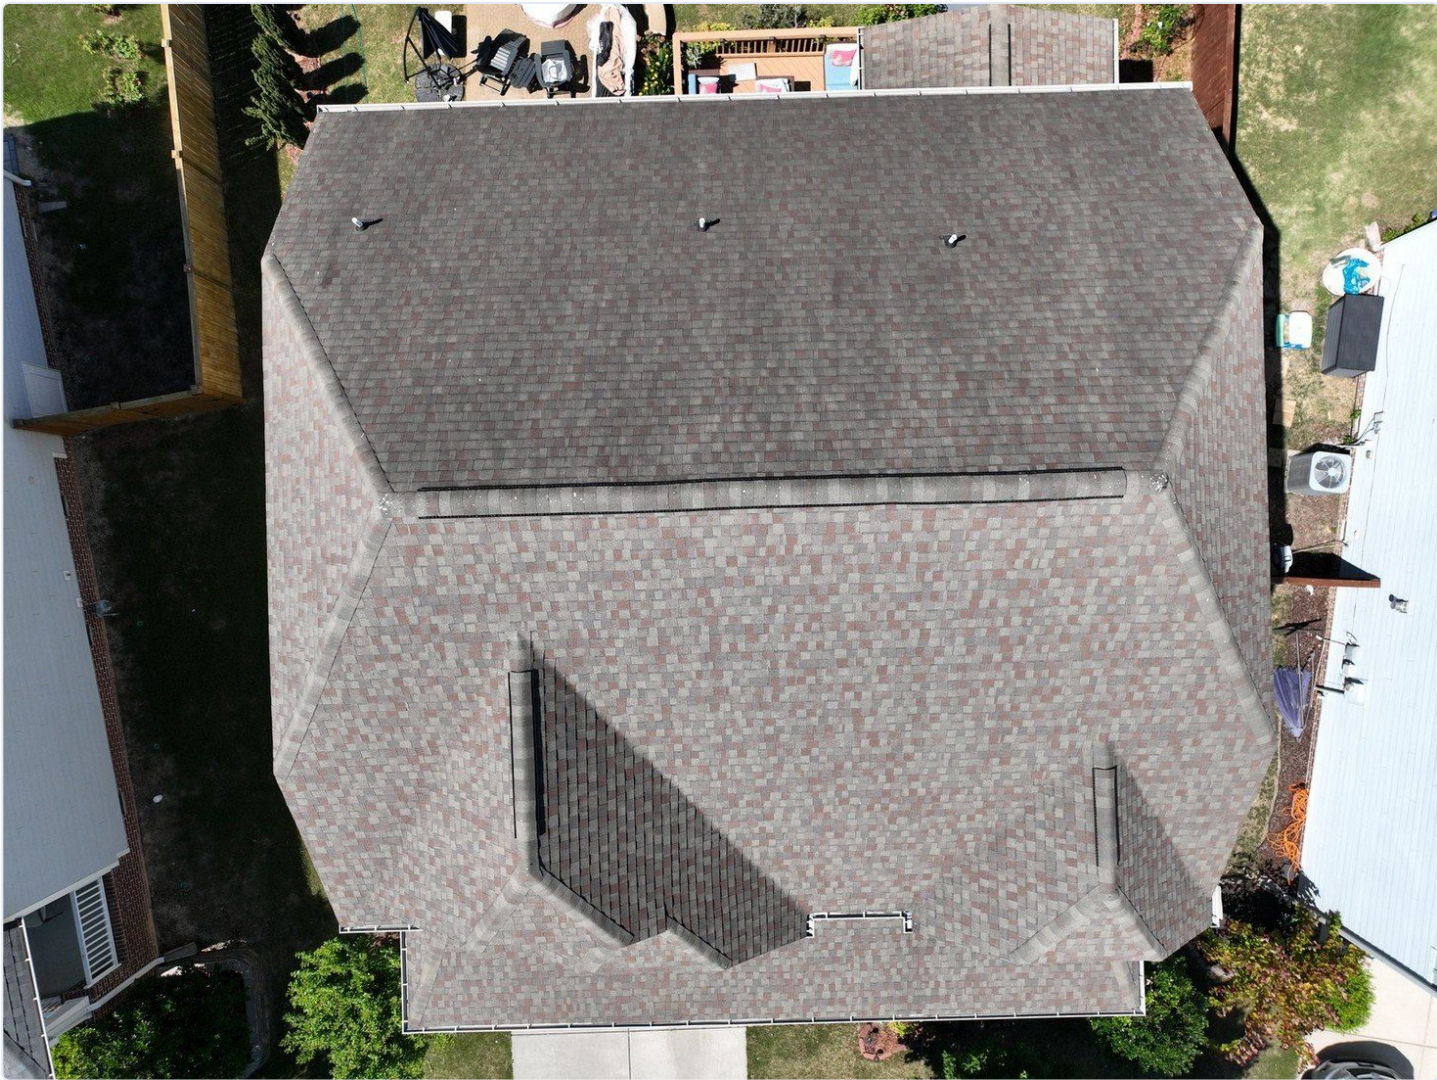
| LOCATION | OBSERVATION | SEVERITY |
|---|---|---|
| All roof planes | Uniform architectural asphalt shingle; coverage complete. No missing or lifted tabs, no tarping or patching, no displaced ridge caps (Figs. 1–4) | LOW |

Fig. 1 — Plan view of the main structure — hip-and-gable roof, attached wing and dormer in one frame.

No action is indicated by this capture. Continue routine seasonal checks. Fastener heads, flashing beneath shingle courses and any sub-surface condition were not assessable from this altitude and should be confirmed at close range if a full condition assessment is required.

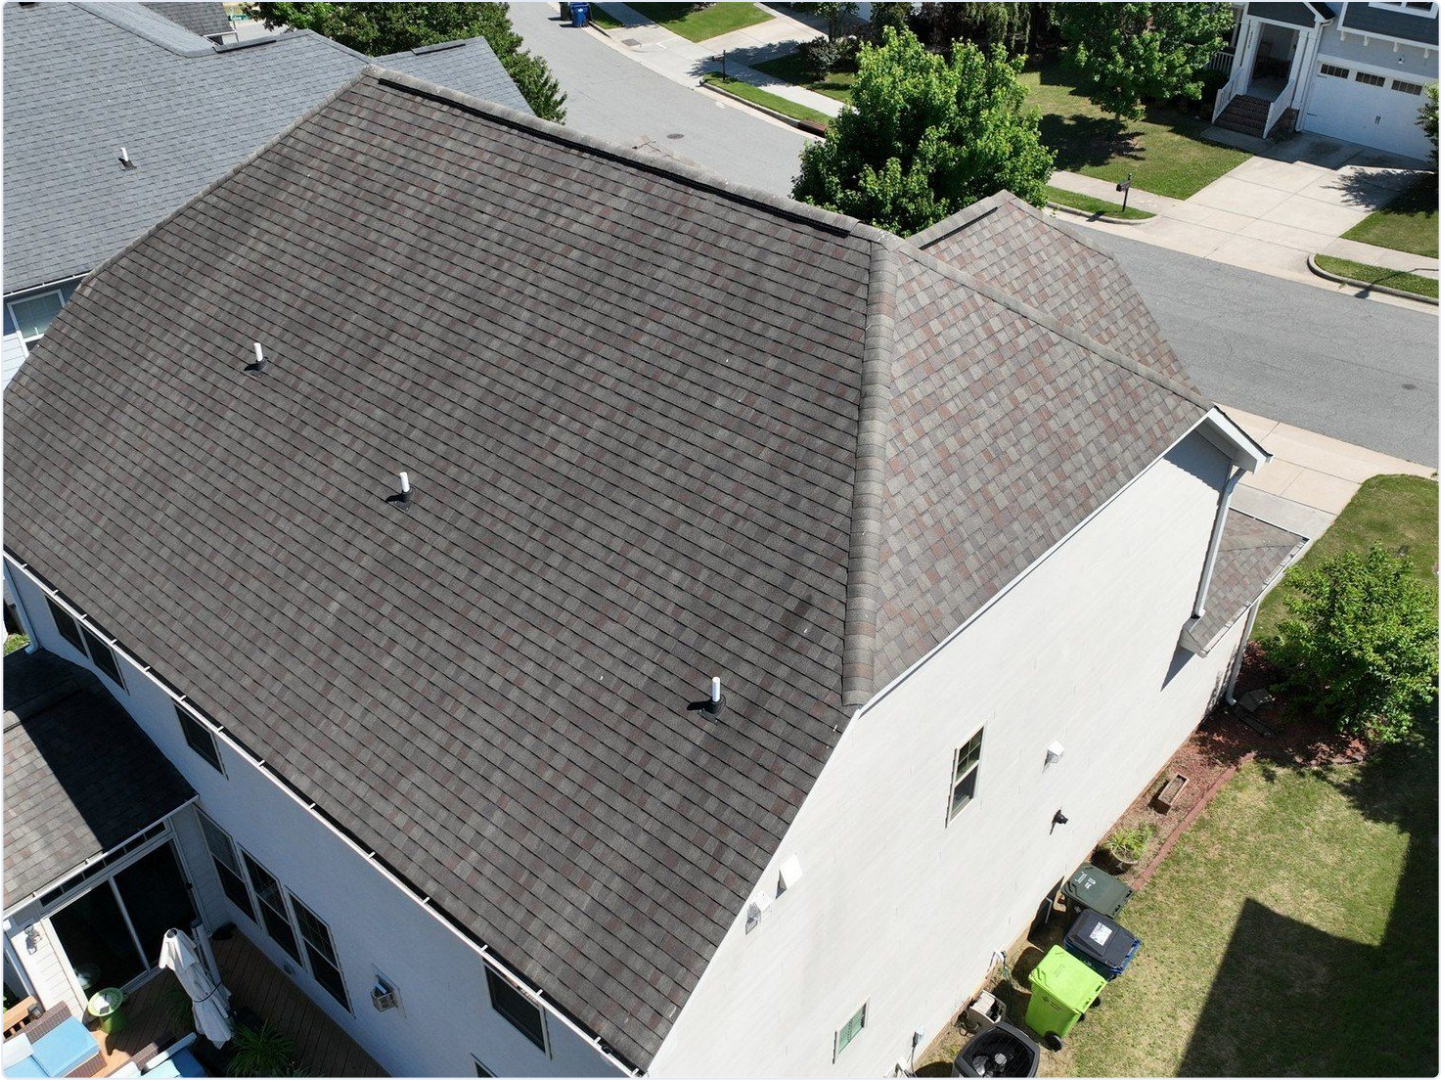
*Fig. 2 — Oblique across the front planes; uniform shingle field and continuous gutter line.*

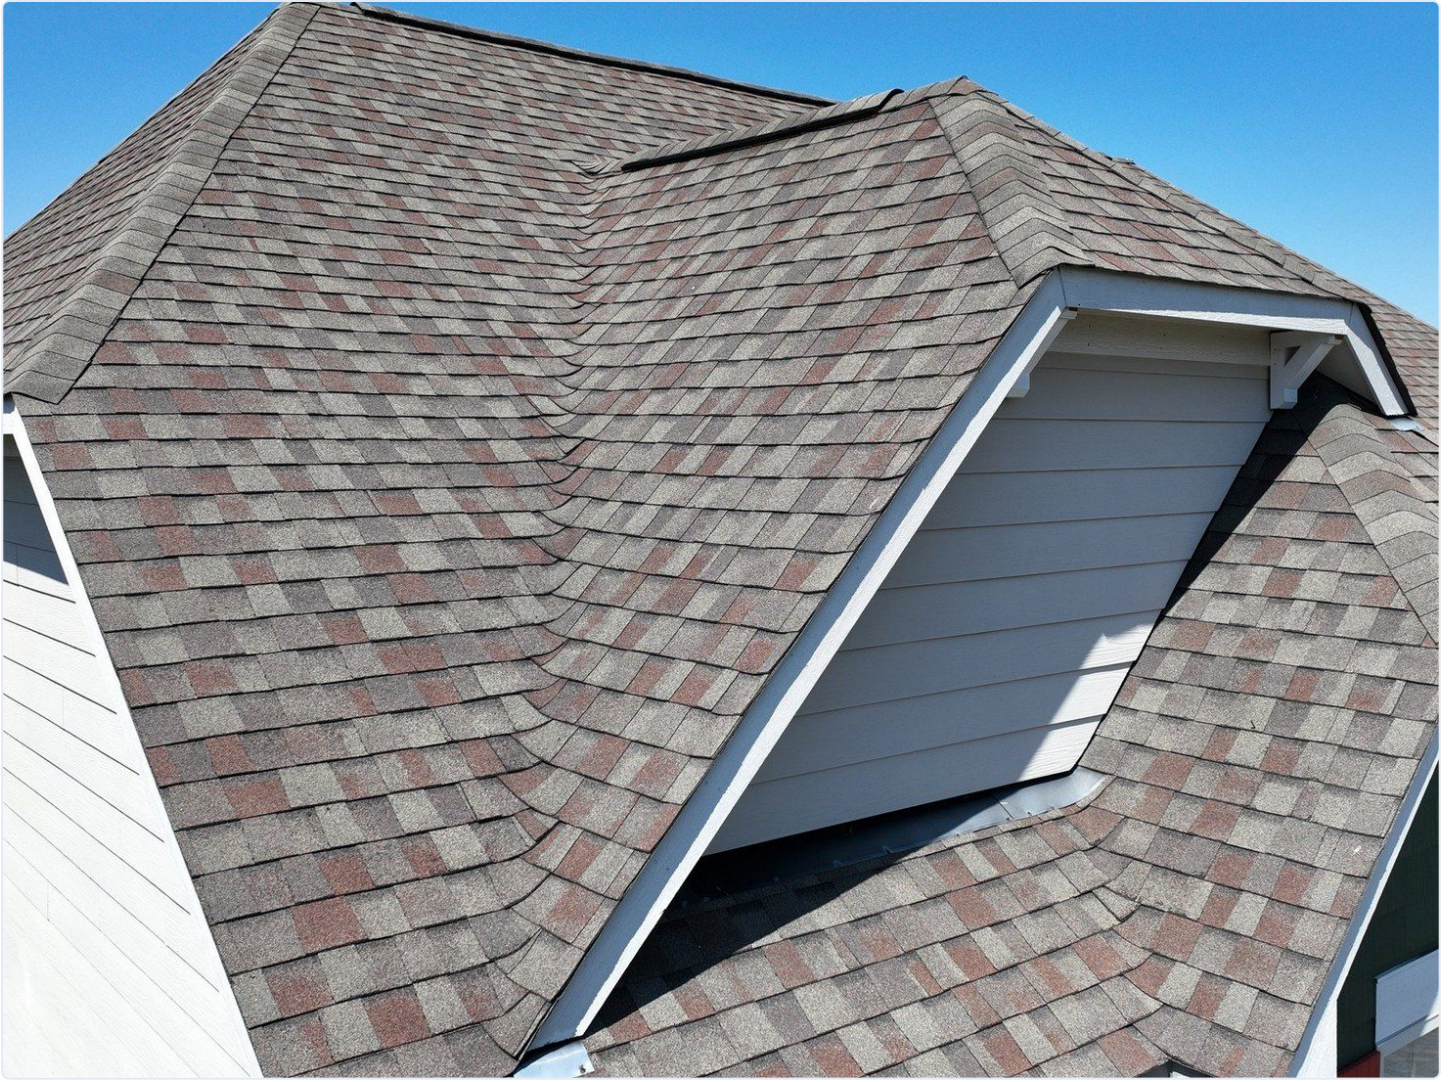
| LOCATION | OBSERVATION | SEVERITY |
|---|---|---|
| Perimeter and eave | Drip edge, flashing and gutter line appear seated and correctly lapped where visible (Fig. 3) | LOW |

*Fig. 3 — Perimeter and eave detail — drip edge, flashing and gutter line.*

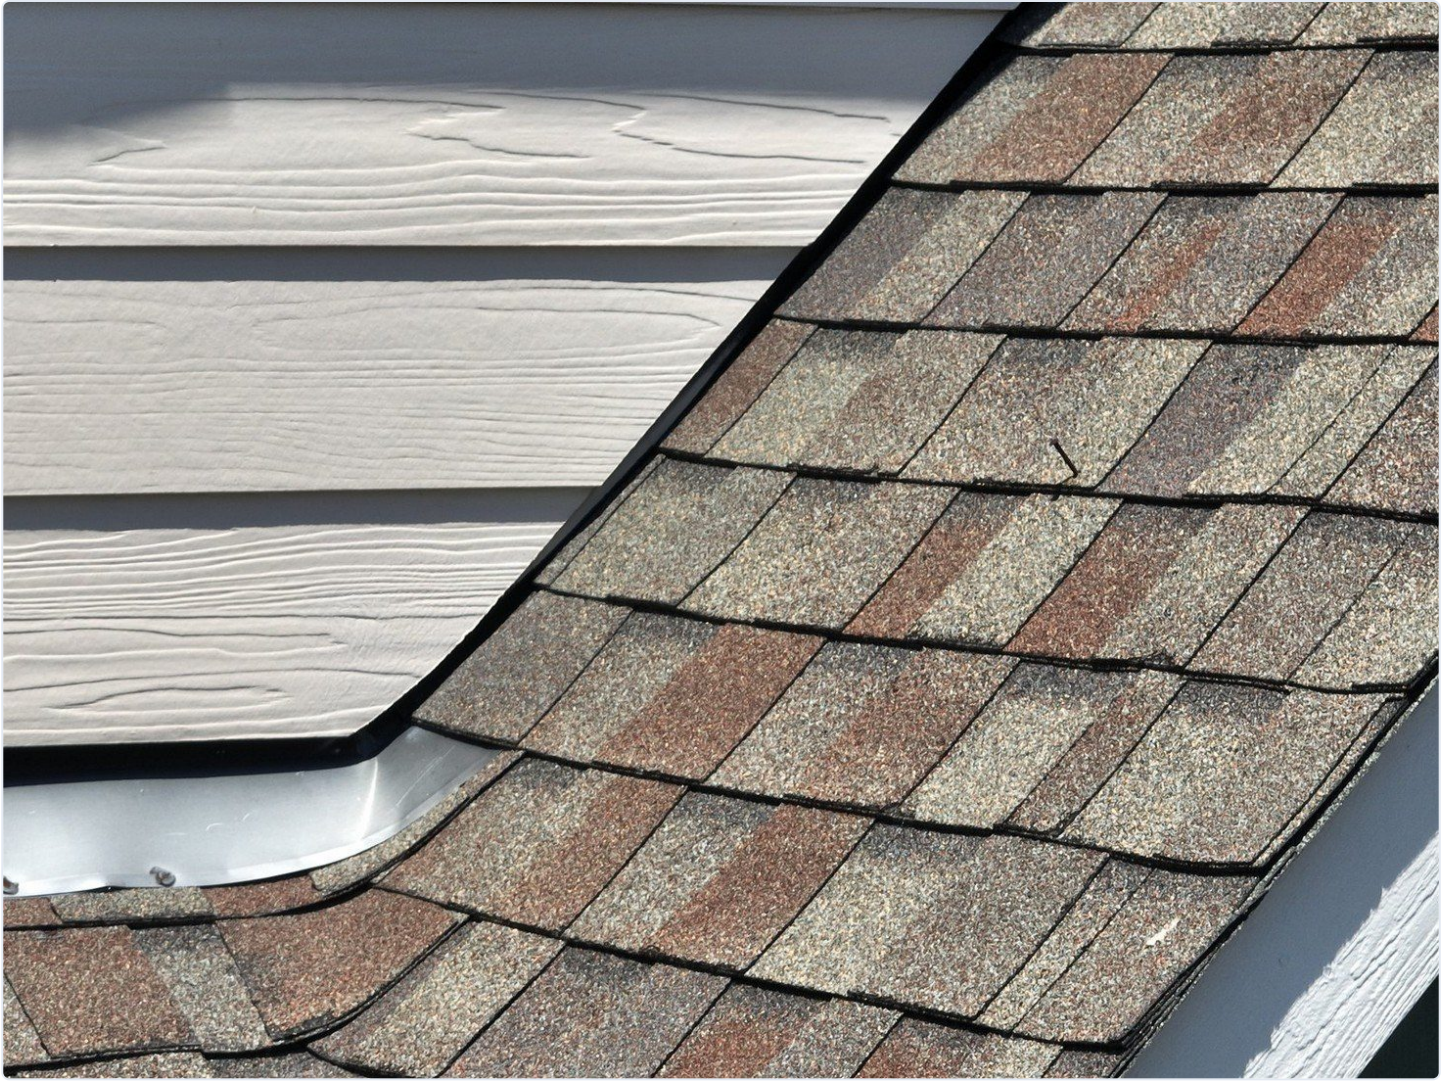
*Fig. 4 — Shingle field at close range; courses uniform, no lifted or missing tabs observed.*
