## QUARTERLY PROPERTY SURVEY

Managed residential community · four structures under one owner · quarter withheld

| <b>Portfolio</b> | 3 residential buildings + clubhouse · one community | <b>Report ID</b> | MWA-SMP-0008 |
| <b>Survey quarter</b> | Q2 (Apr–Jun) | <b>Prior survey</b> | Q1 baseline |

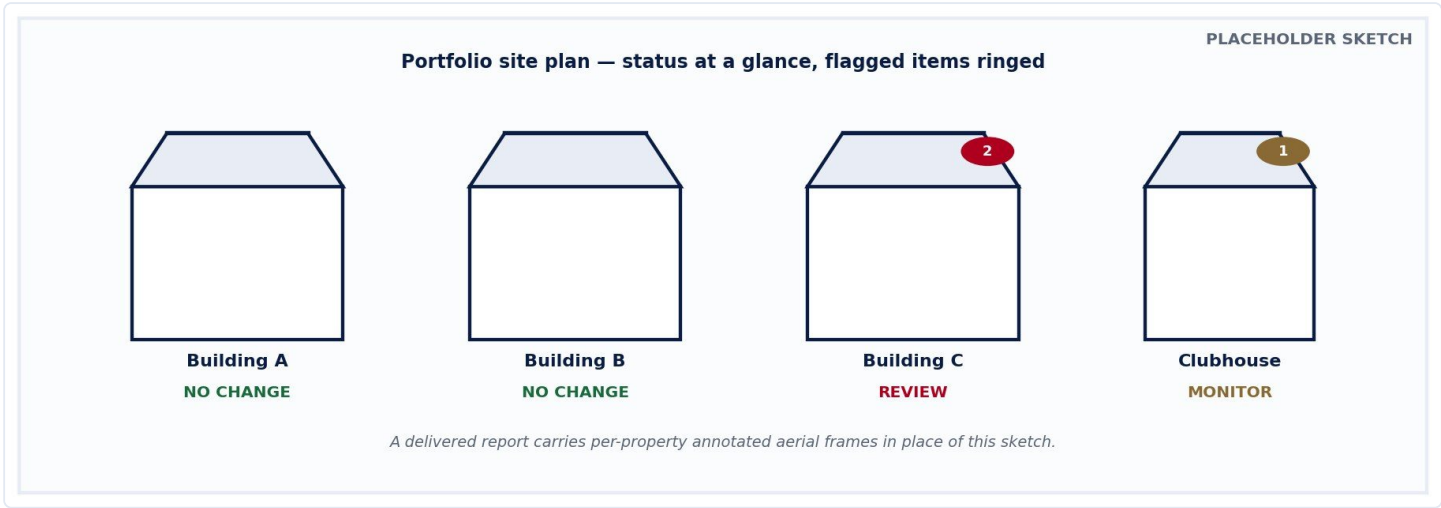
| LOCATION | OBSERVATION | SEVERITY |
|---|---|---|
| Building C — west elevation | New displaced shingles relative to the Q1 baseline; flagged REVIEW for contractor pricing. Cause not determined (Fig. 1) | MEDIUM |
| Clubhouse | Minor observation carried forward from Q1; flagged MONITOR, no action indicated this quarter (Fig. 1) | LOW |
| Buildings A and B | No material change observed from the Q1 baseline across roof planes and perimeter (Fig. 1) | LOW |

Fig. 1 — Portfolio site plan — status at a glance across the four structures, flagged items ringed. A delivered report carries the annotated aerial frames per structure in place of this sketch.

Building C west elevation should be priced by the client's roofing contractor. The clubhouse observation is carried to Q3 for comparison rather than actioned. Buildings A and B require no action this quarter. Retain this survey as the Q2 reference; Q3 is flown from the same positions and compared against it.
