## AERIAL ROOF & STORM DAMAGE REPORT

Wind damage documentation · residential roof surfaces and perimeter · capture date withheld

| Property | Street address withheld | Report ID | MWA-SMP-0003 |

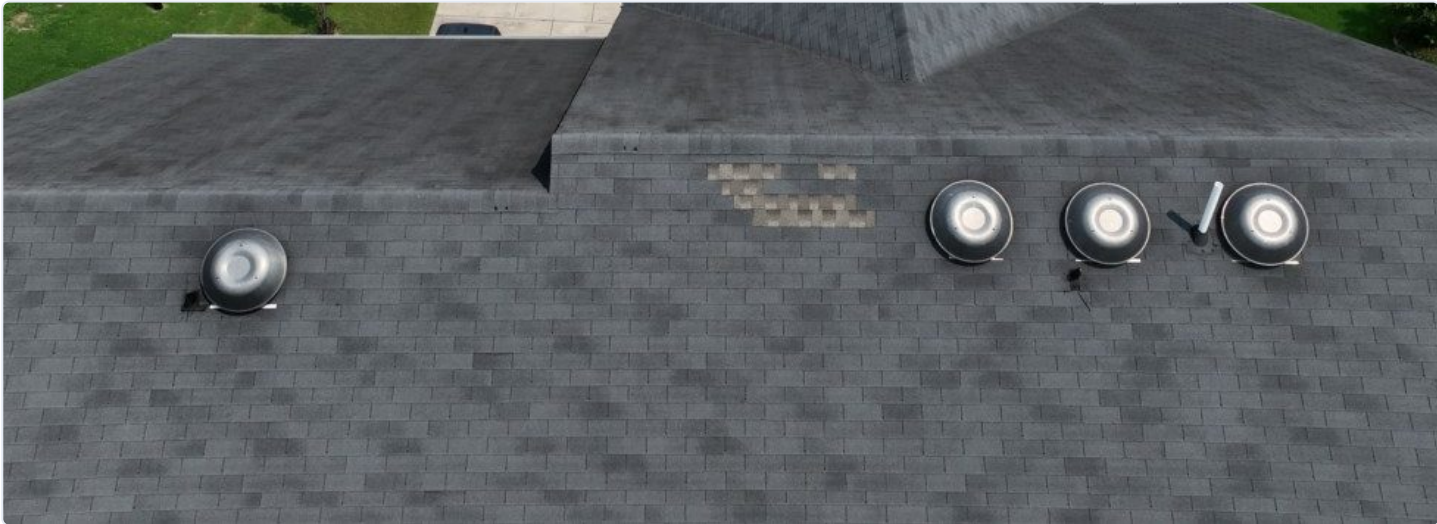
| LOCATION | OBSERVATION | SEVERITY |
|---|---|---|
| Upper south-facing ridge | Approximately 10 missing shingles; exposed underlayment visible across the affected area. Surrounding field intact; no impact marks observed on this plane (Figs. 1–4) | HIGH |

Fig. 1 — Upper south-facing plane. Affected area sits immediately below the ridge; surrounding field, vents and ridge line intact.

Prompt evaluation and repair of the ridge area by a licensed roofing contractor is recommended. Exposed underlayment should be addressed before the next significant rain event to prevent water intrusion. Fastener heads, flashing details at hip and ridge lines, and conditions beneath shingle courses were not assessable from this capture and should be confirmed at close range if a full condition assessment is required. Monitor the discolored area at the valley transition at the next seasonal check.

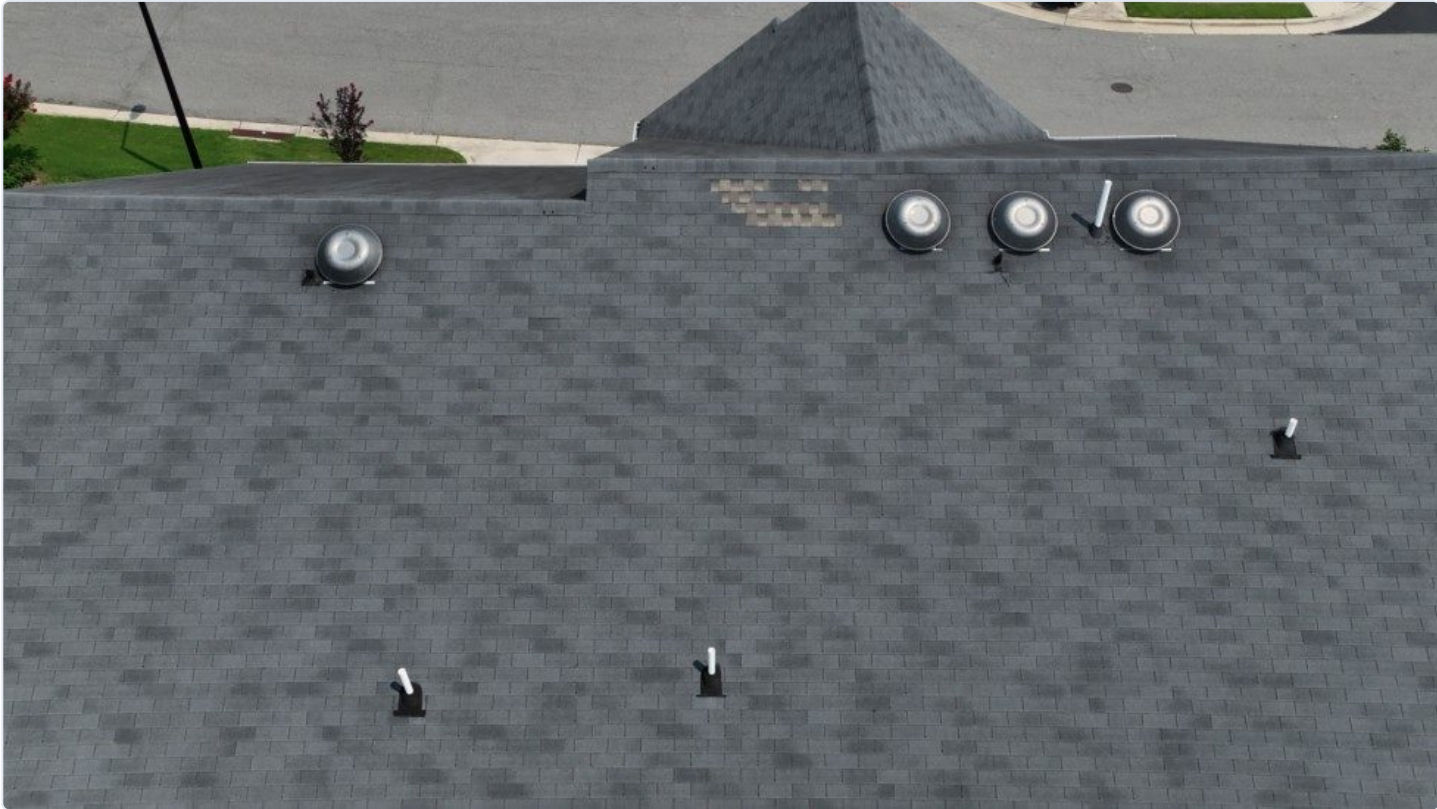
Fig. 2 — Missing shingles along the upper ridge, underlayment exposed across the affected courses.

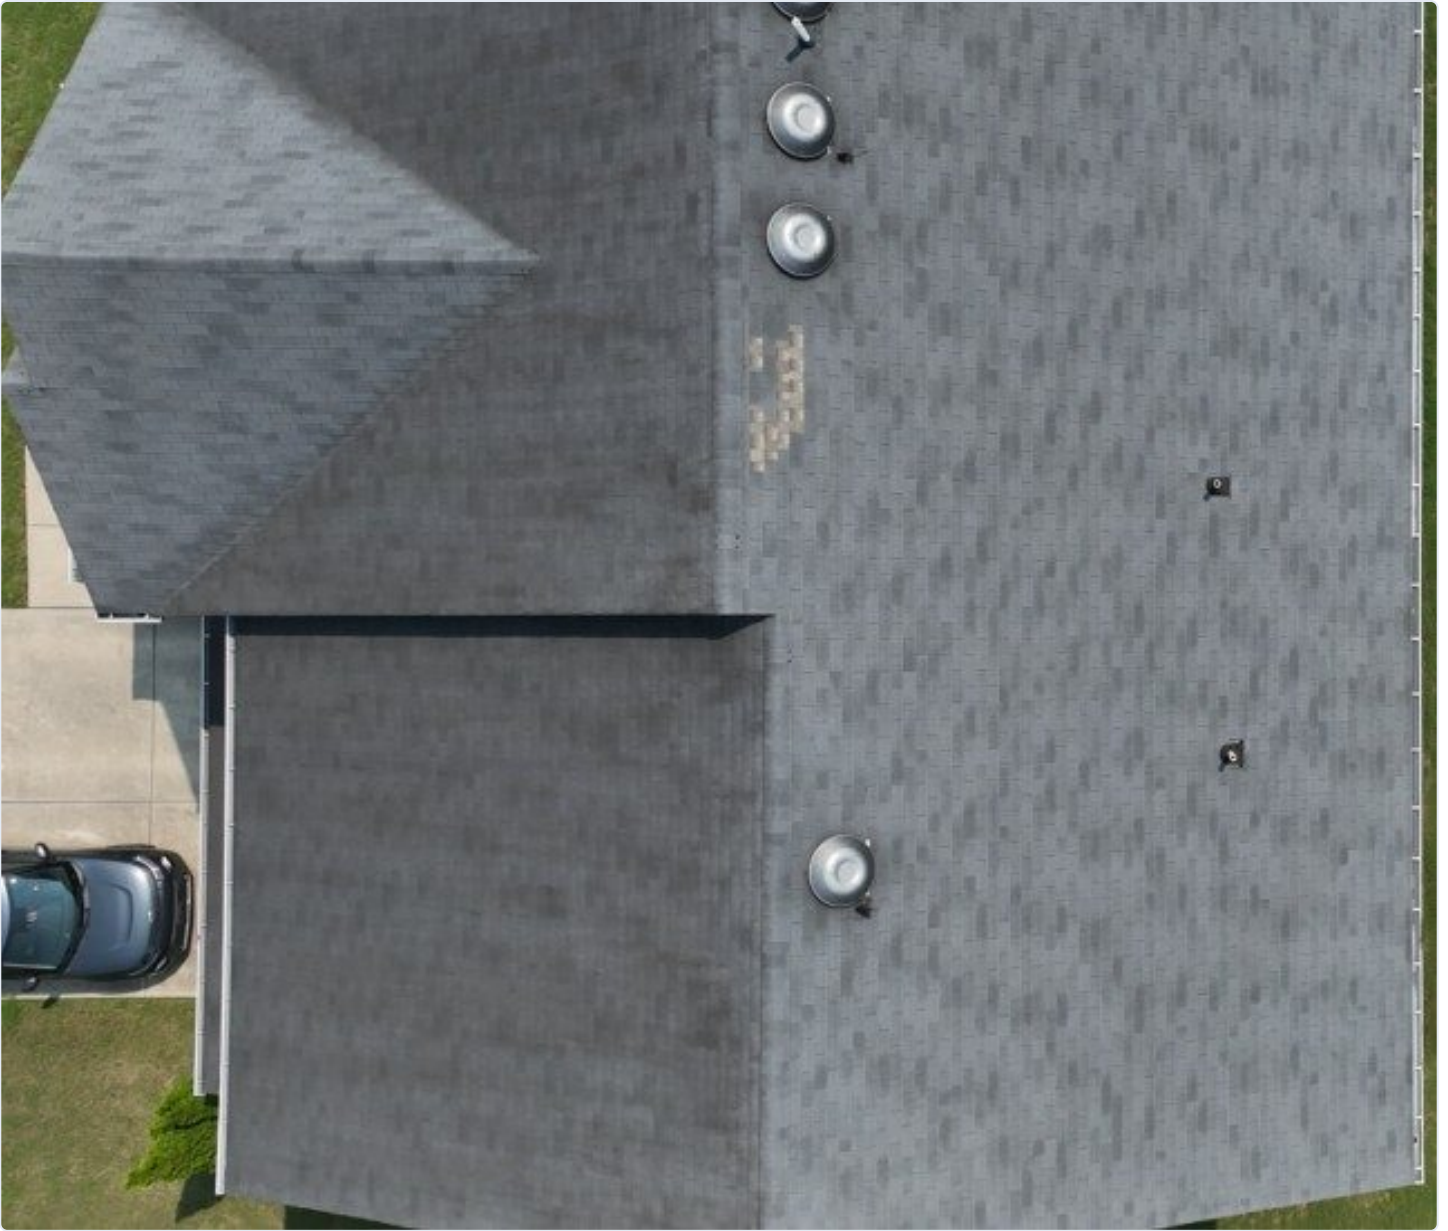
*Fig. 3 — Closer pass on the same area; extent of exposure and boundary of the affected courses.*

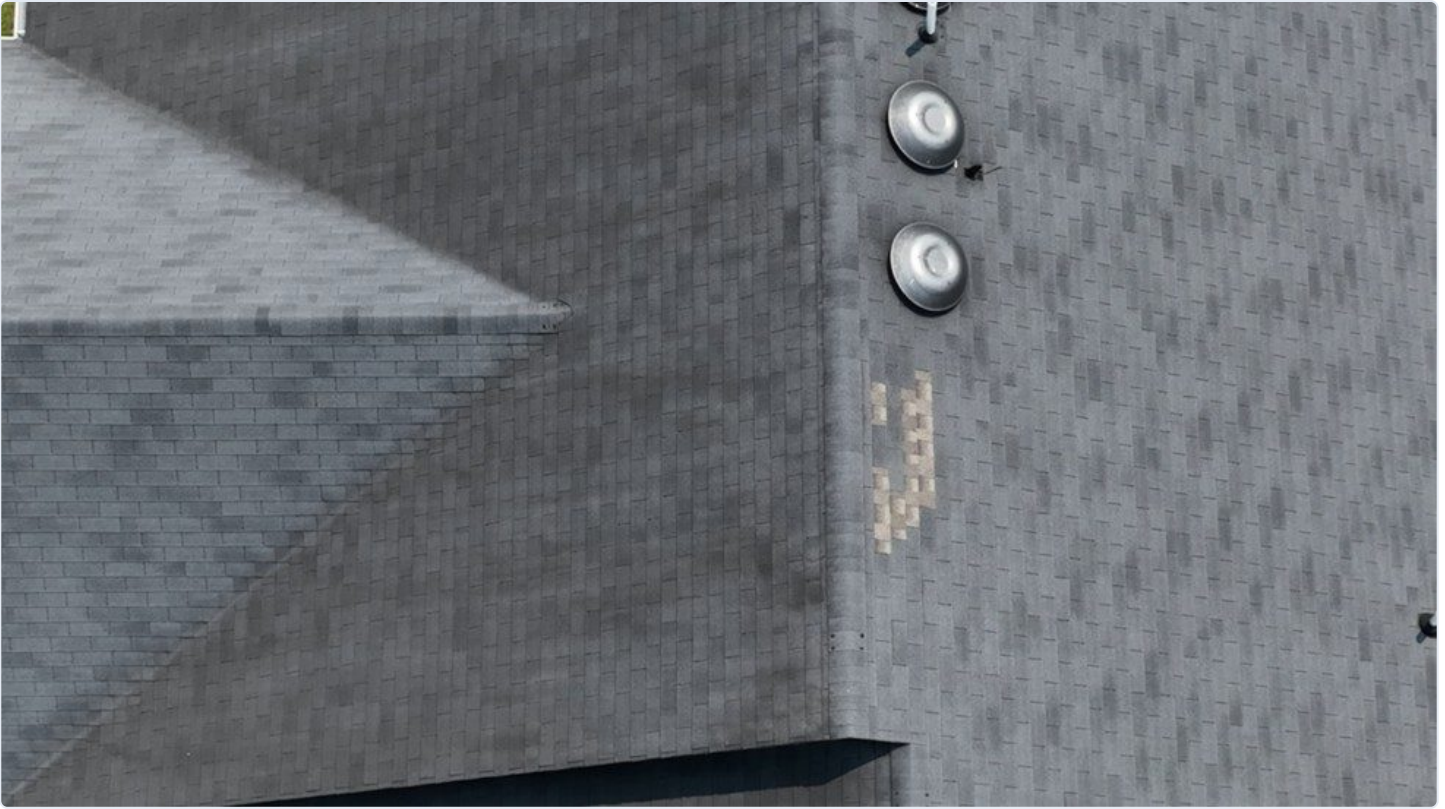
*Fig. 4 — Same finding from the opposing approach. Two angles on one defect.*

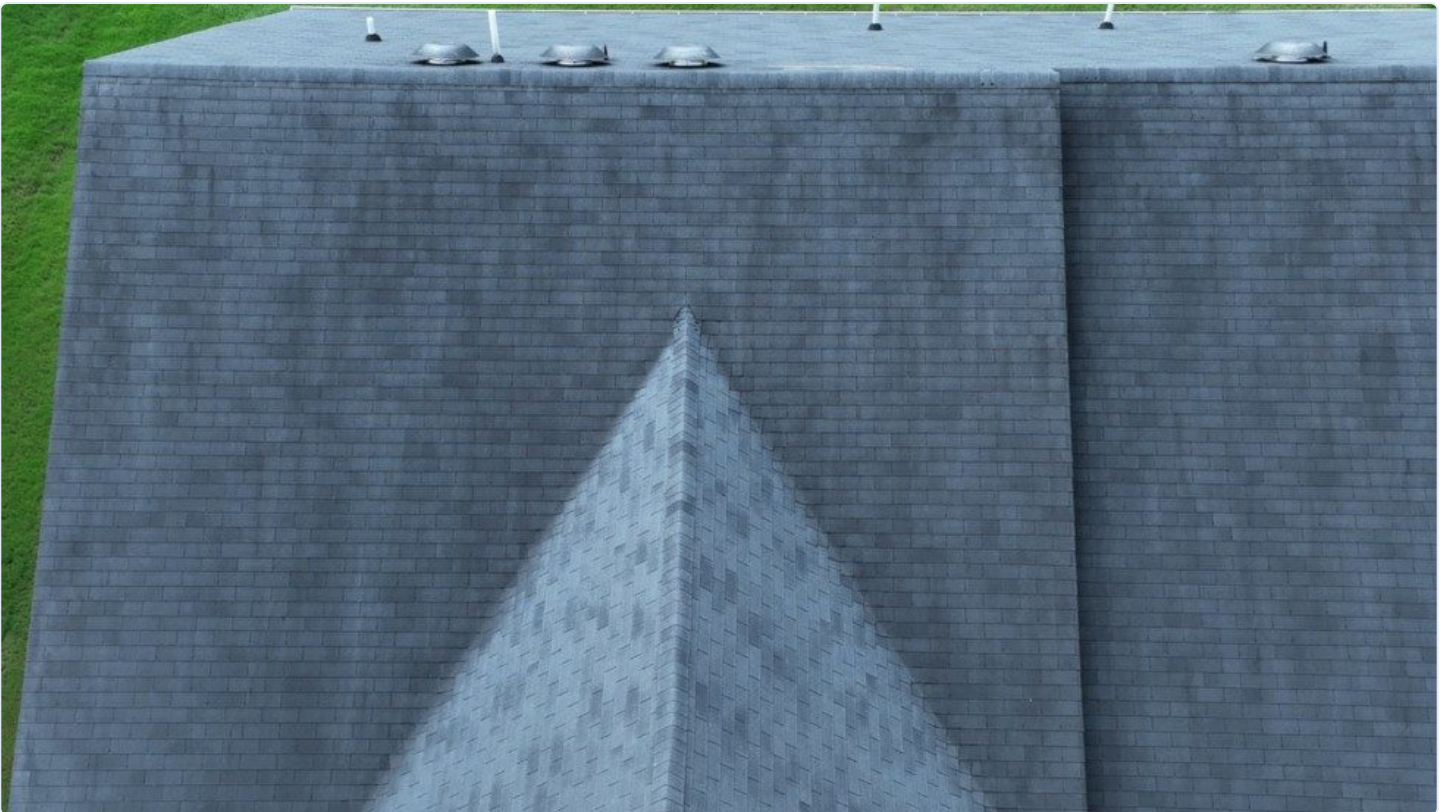
*Fig. 5 — Adjacent plane and hip transition. Uniform shingle field; no missing material observed.*

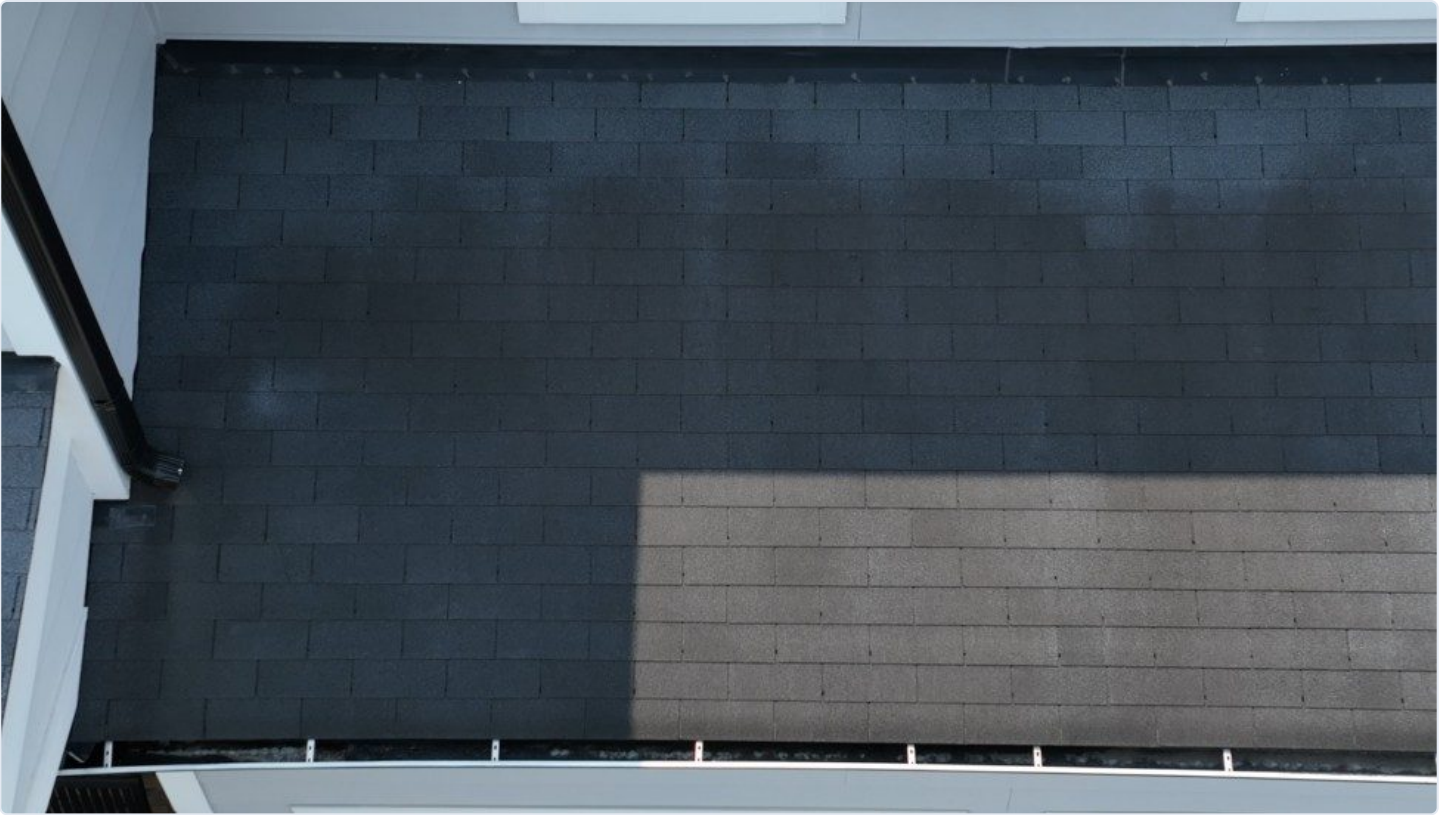
| LOCATION | OBSERVATION | SEVERITY |
|---|---|---|
| Valley / hip transition, north-facing | Localized surface discoloration near the valley transition; cause and depth of any material change are not determinable at this resolution (Figs. 6–7) | LOW |

*Fig. 6 — Valley transition and gutter line. Localized surface discoloration noted as a LOW observation.*

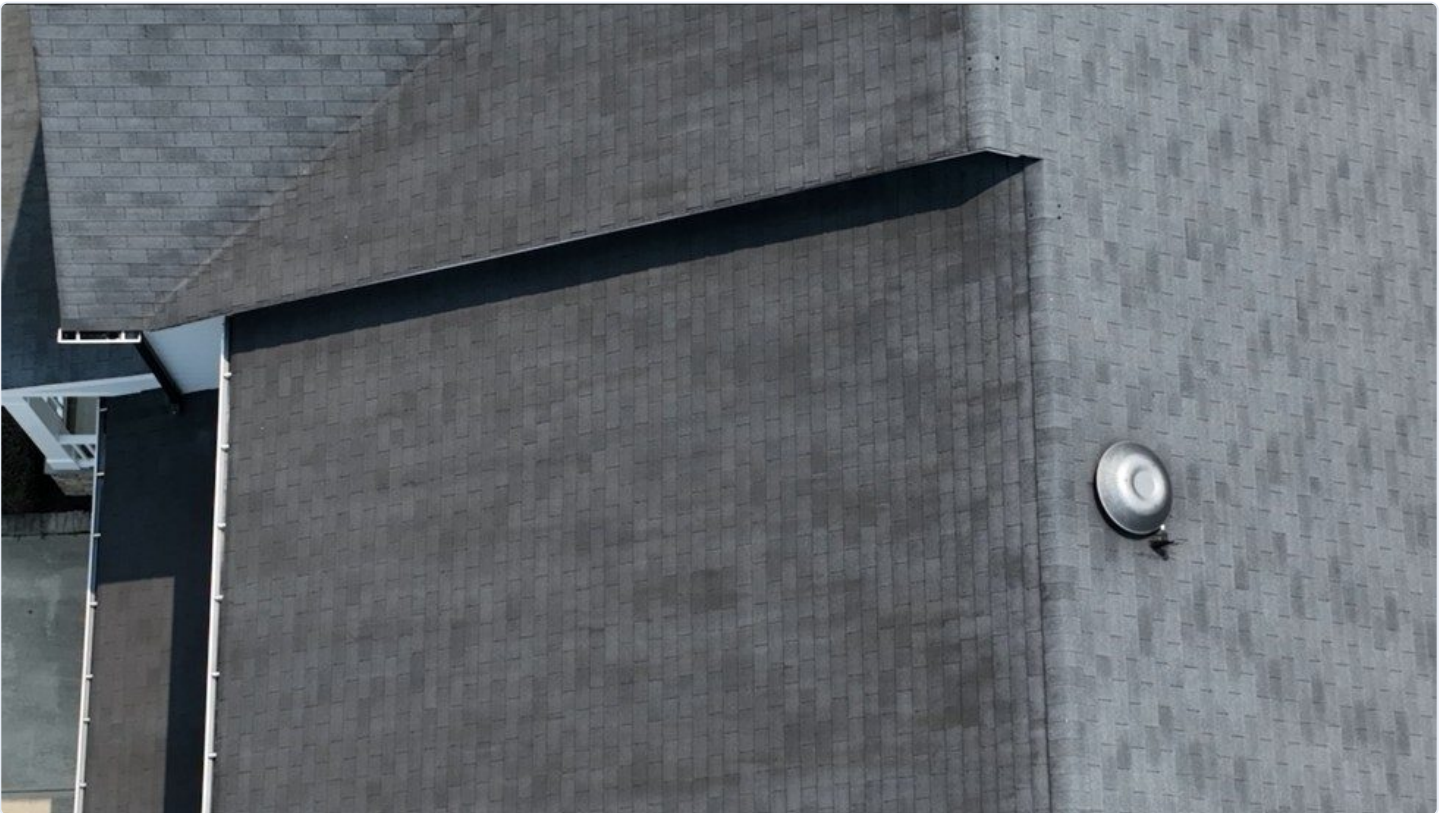
*Fig. 7 — Perimeter and vent cluster. Vents seated; no displacement observed.*
